**ANALYSIS OF BROWNFIELDS CLEANUP ALTERNATIVES &  
CONCEPTUAL REMEDIAL ACTION PLAN  
FORSTER MANUFACTURING  
581 DEPOT STREET  
WILTON, MAINE  
REV. 0**

Town of Wilton, Maine  
158 Weld Road  
Wilton, Maine

**Ransom Consulting, Inc.**  
400 Commercial Street, Suite 404  
Portland, Maine 04101  
(207) 772-2891

Project 161.06104  
September 18, 2017

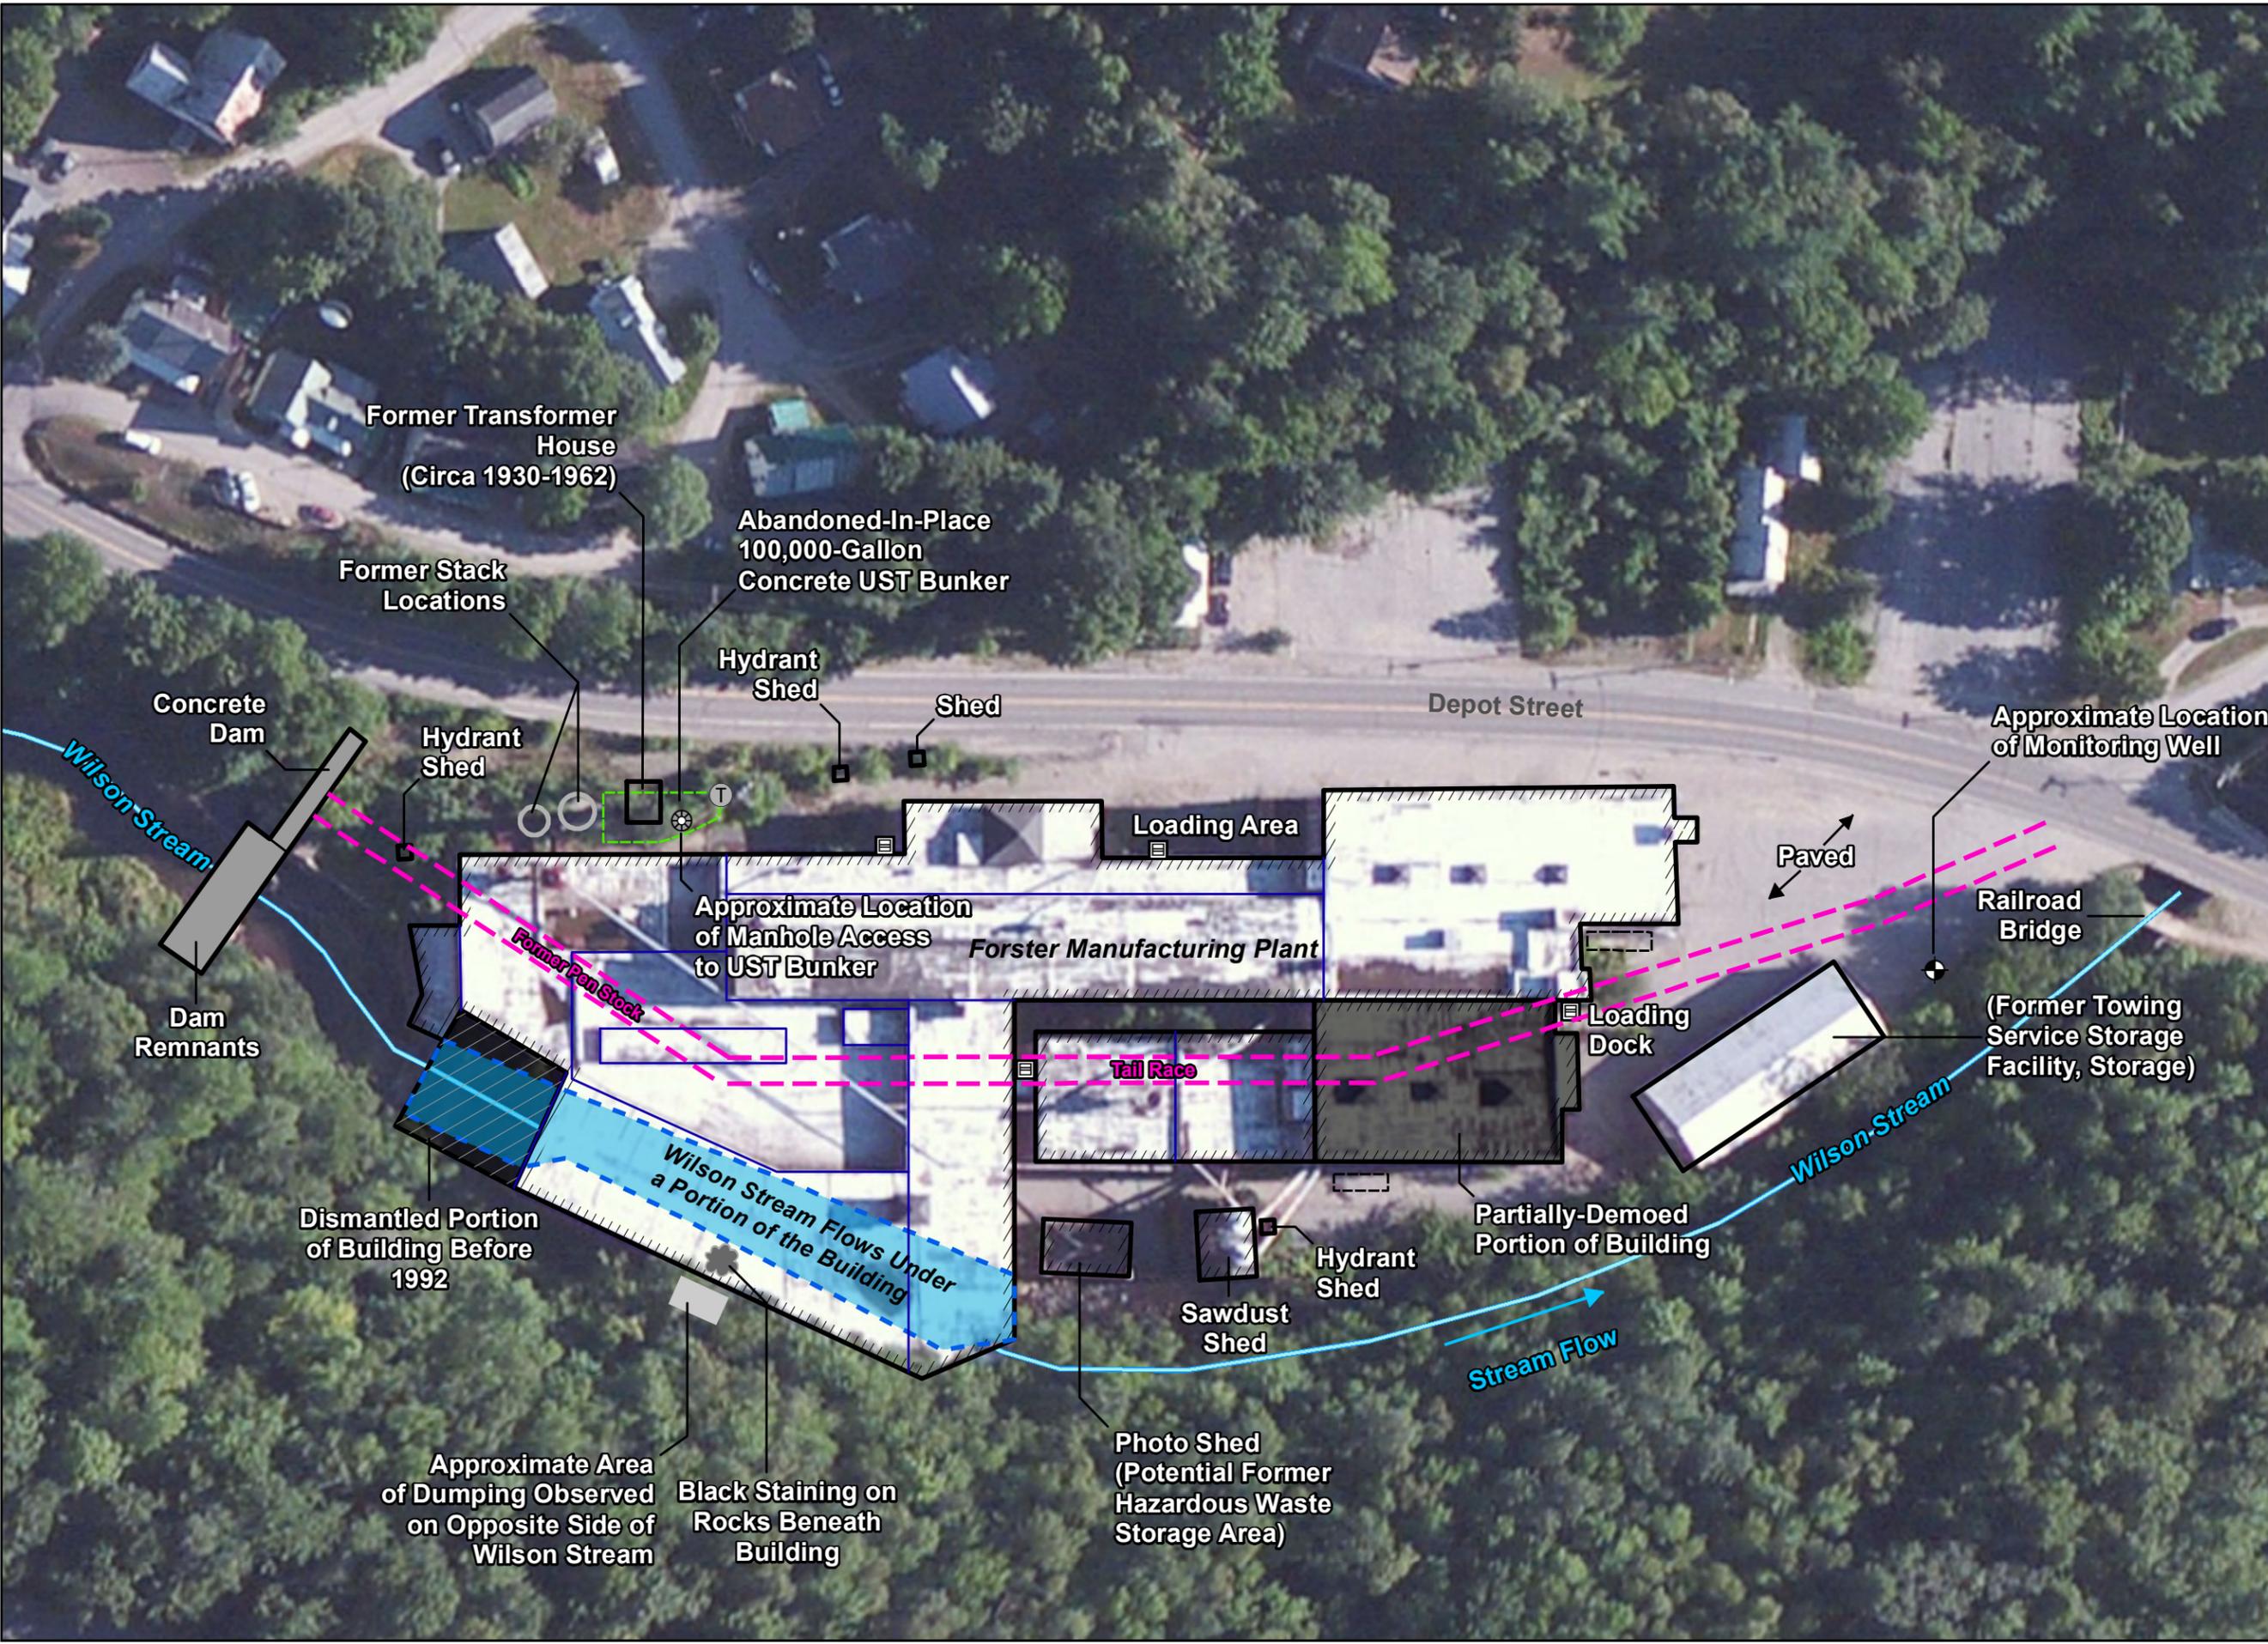
**Figure 2**  
Site Plan

Remaining portions of the Site are generally impervious, with paved parking areas to the east and south, paved loading docks and parking areas to the north, and small areas of grassy/overgrowth in the western and northwestern portion of the Site. The southern Site boundary is an approximately three-foot-high concrete wall, which comprises the northern bank of Wilson Stream. In the northwestern portion of the Site, the former locations of two stacks could be observed, as well as an abandoned-in-place concrete oil vault with protruding process pipes. Please refer to the appended Site Plan (Figure 2) for the location of key site features.

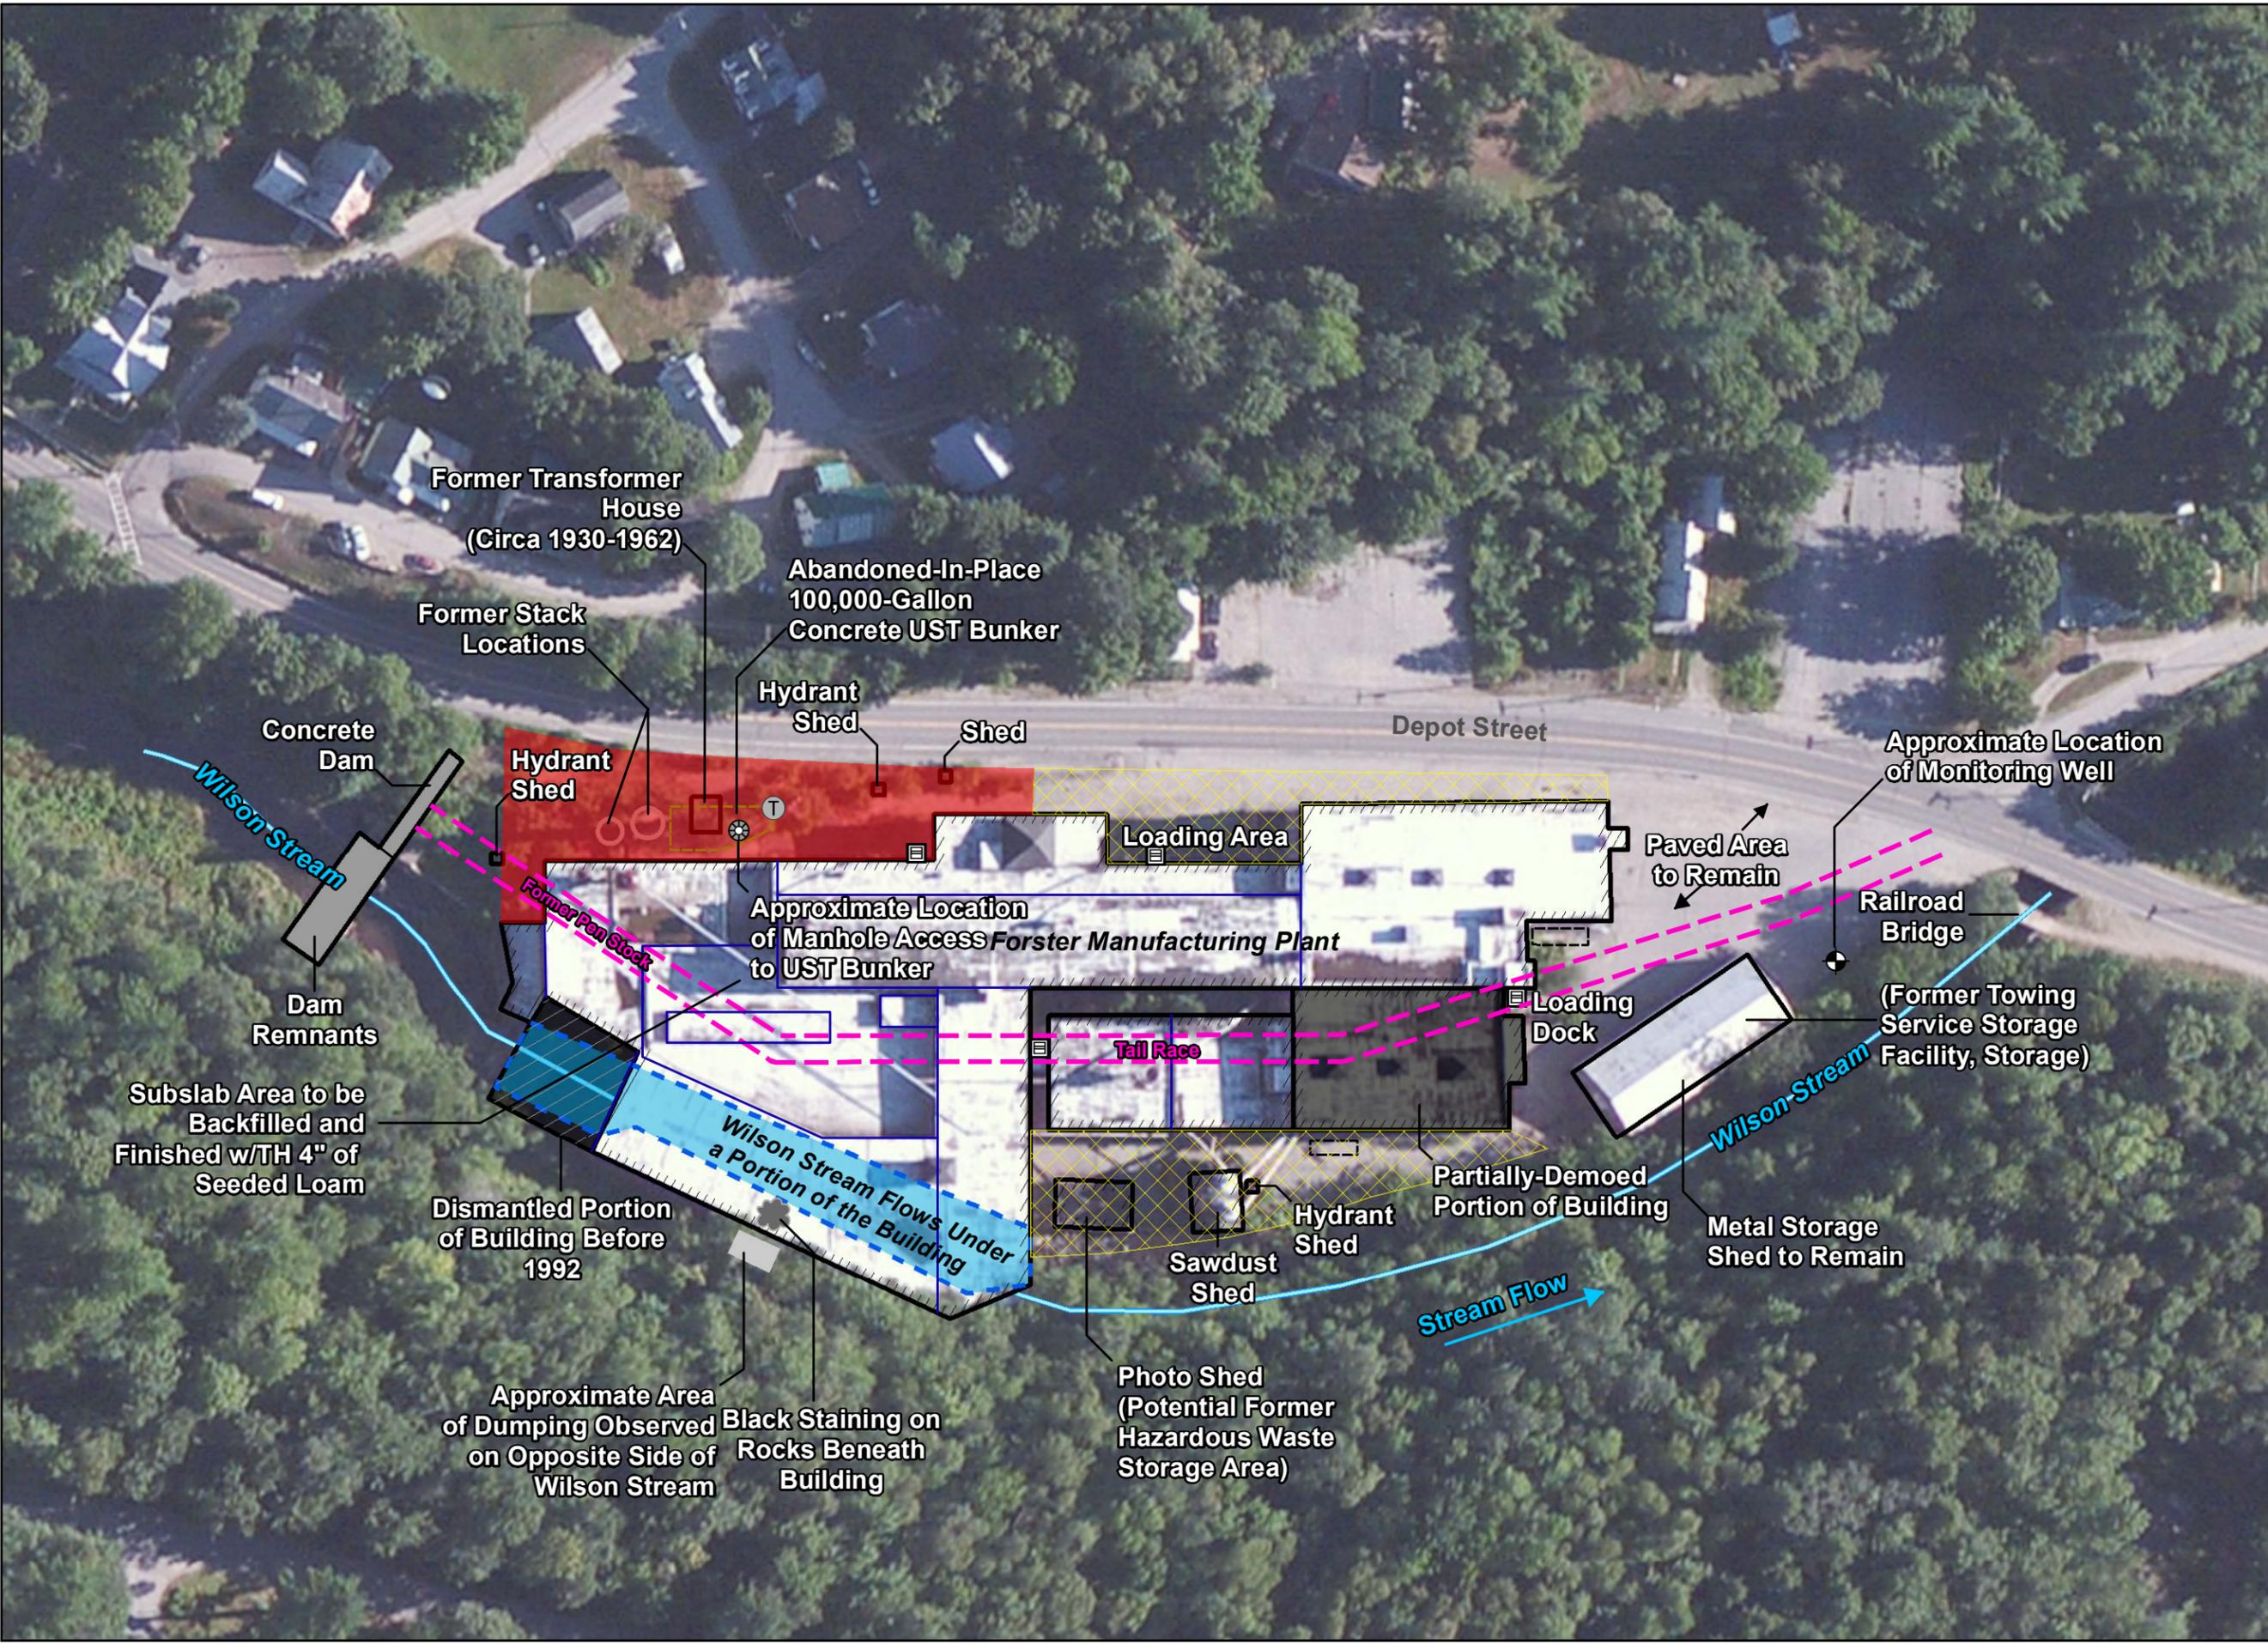
**Figure 3**  
Proposed Soil Mitigation System

It should be noted that existing pavement in the southern portion of the Site and approximately half of the northern portion of the Site would remain and act as a barrier cover system. This pavement is currently preventing human exposure to the underlying contaminated soils through direct contact, ingestion, or inhalation, and as such, it shall remain.

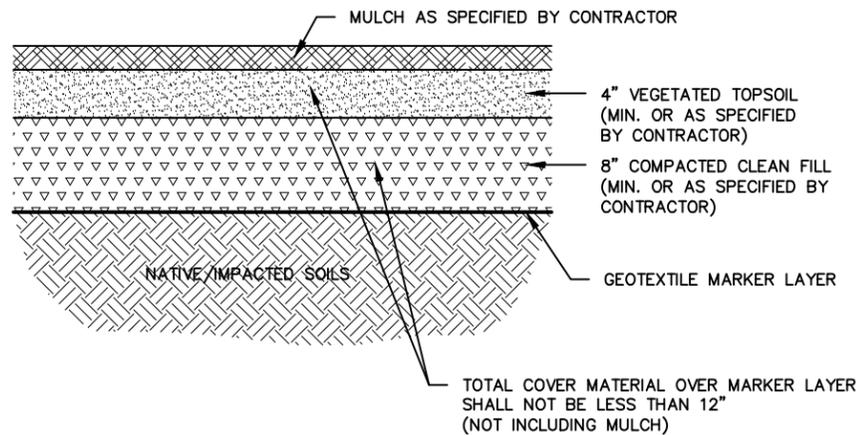
**COVER SYSTEM TYPE 1:  
LANDSCAPE COVER PLUS MARKER LAYER**  
NOT TO SCALE

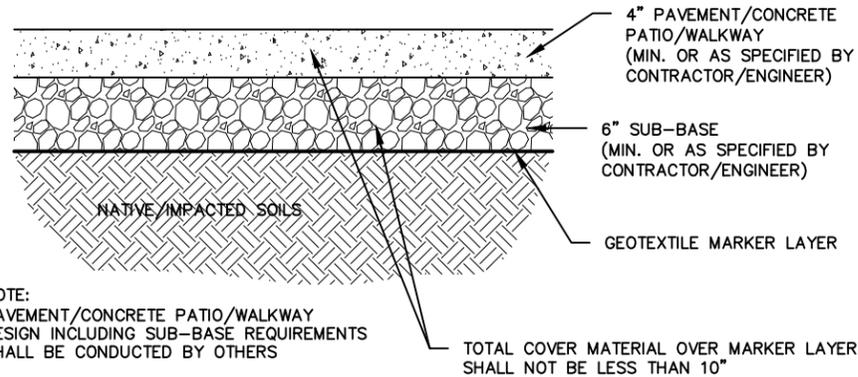
**COVER SYSTEM TYPE 2:  
NEW ASPHALT/CONCRETE COVER PLUS MARKER LAYER**  
NOT TO SCALE

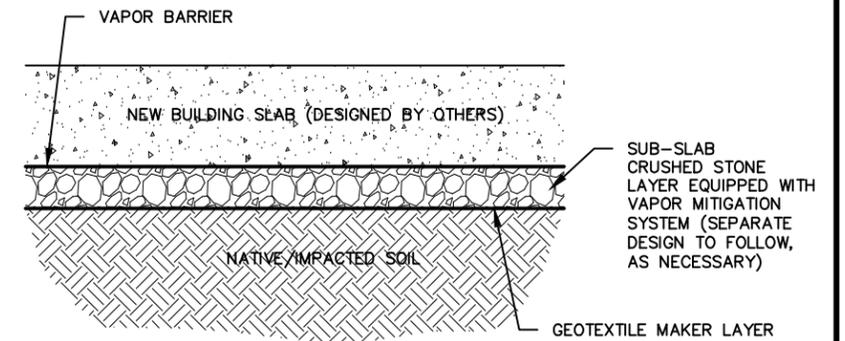
**COVER SYSTEM TYPE 3:  
STRUCTURE/BUILDING FOUNDATION COVER**  
NOT TO SCALE

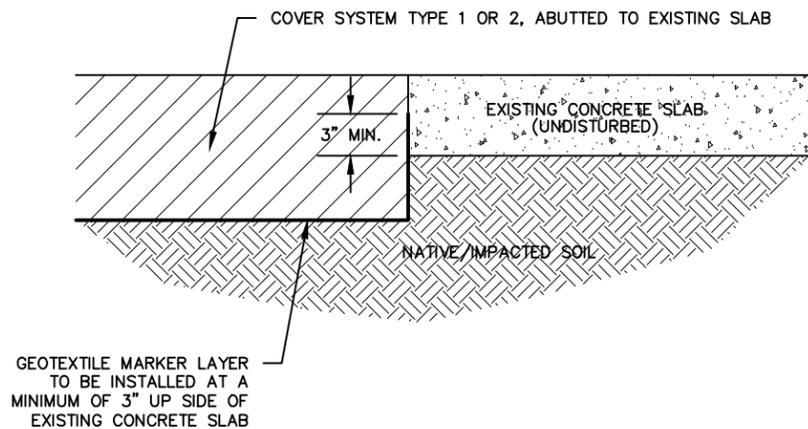
**COVER SYSTEMS ABUTTING EXISTING CONCRETE SLABS**  
NOT TO SCALE

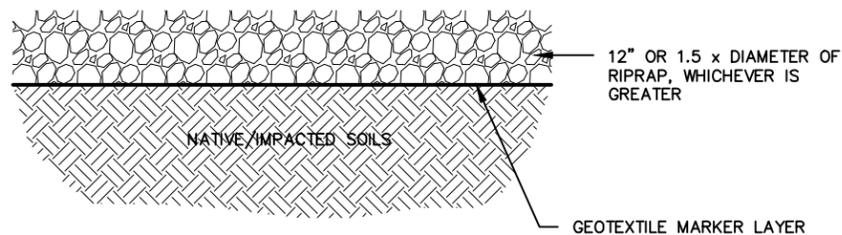
**COVER SYSTEM TYPE 4:  
RIPRAP COVER (STREAM BANK)**  
NOT TO SCALE

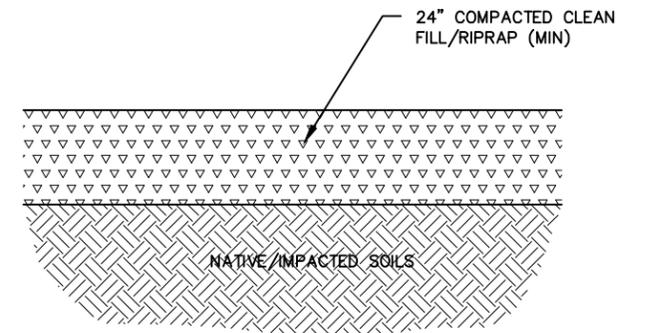
**COVER SYSTEM TYPE 5: CLEAN FILL**  
NOT TO SCALE  
NOTE: NO MARKER LAYER NECESSARY IF COVER SYSTEM IS GREATER THAN 24 INCHES
